# Photographic Record Cascade Mine Drainage

DSL-AMRB 91-001

Near Towns of Centerville, Stockett and Belt  
Cascade County, Montana

December, 1992  
Robert Peccia & Associates

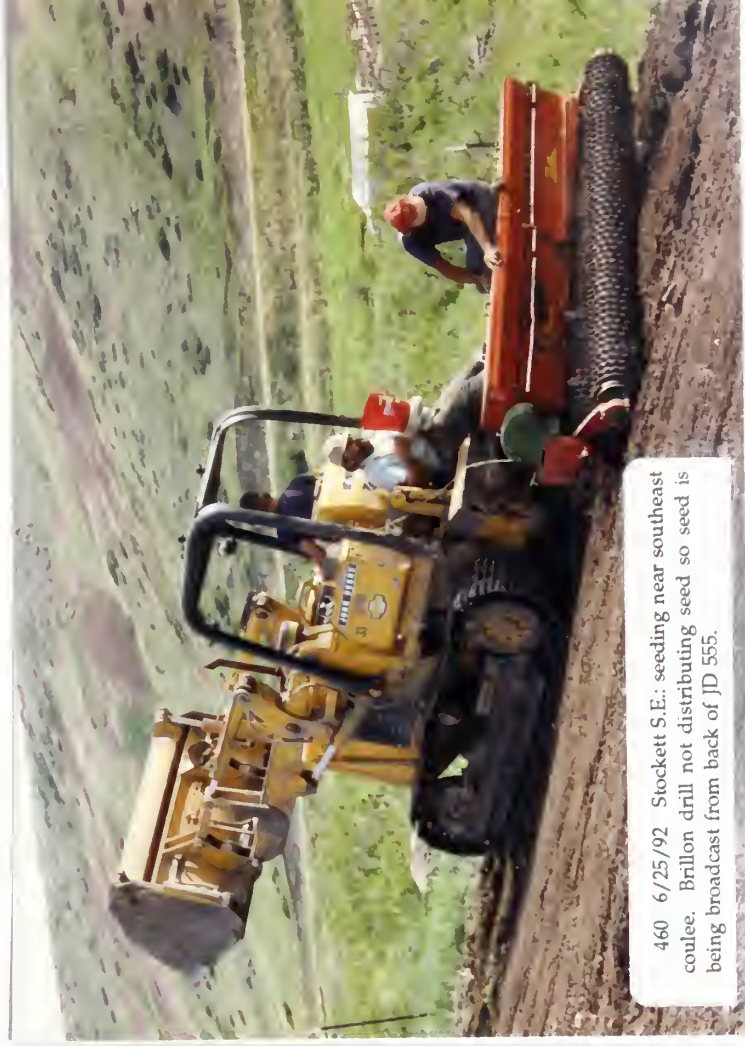
460 6/25/92 Stockett S.E.: seeding near southeast coulee. Brillon drill not distributing seed so seed is being broadcast from back of JD 555.

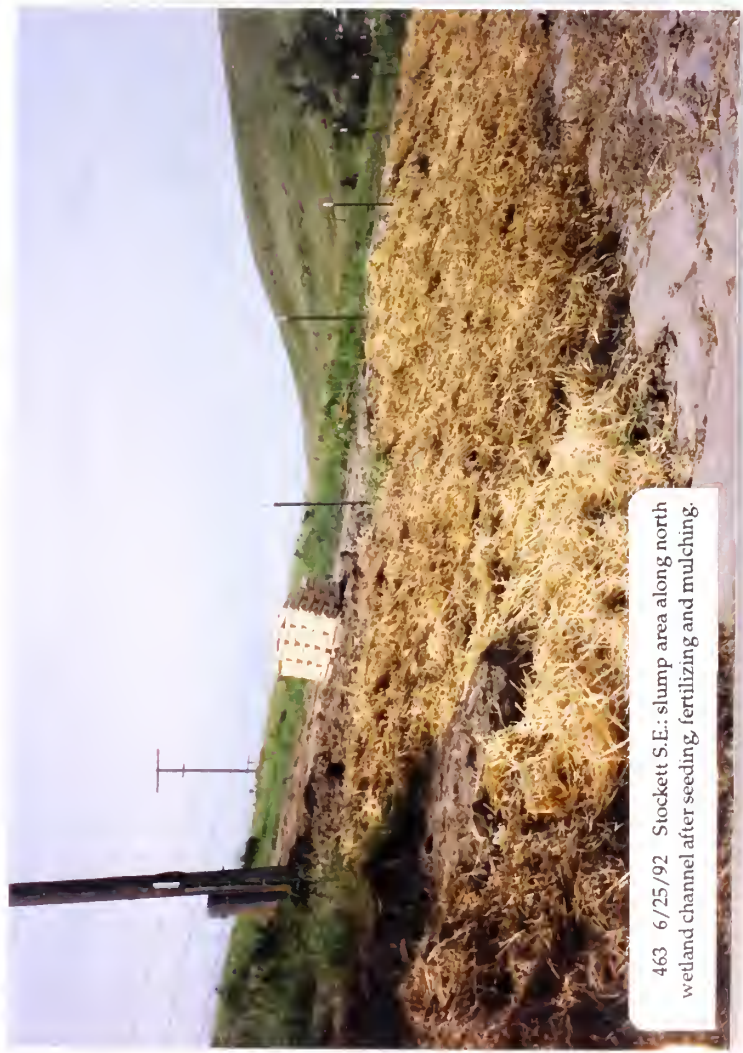
463 6/25/92 Stockett S.E.: slump area along north wetland channel after seeding, fertilizing and mulching.

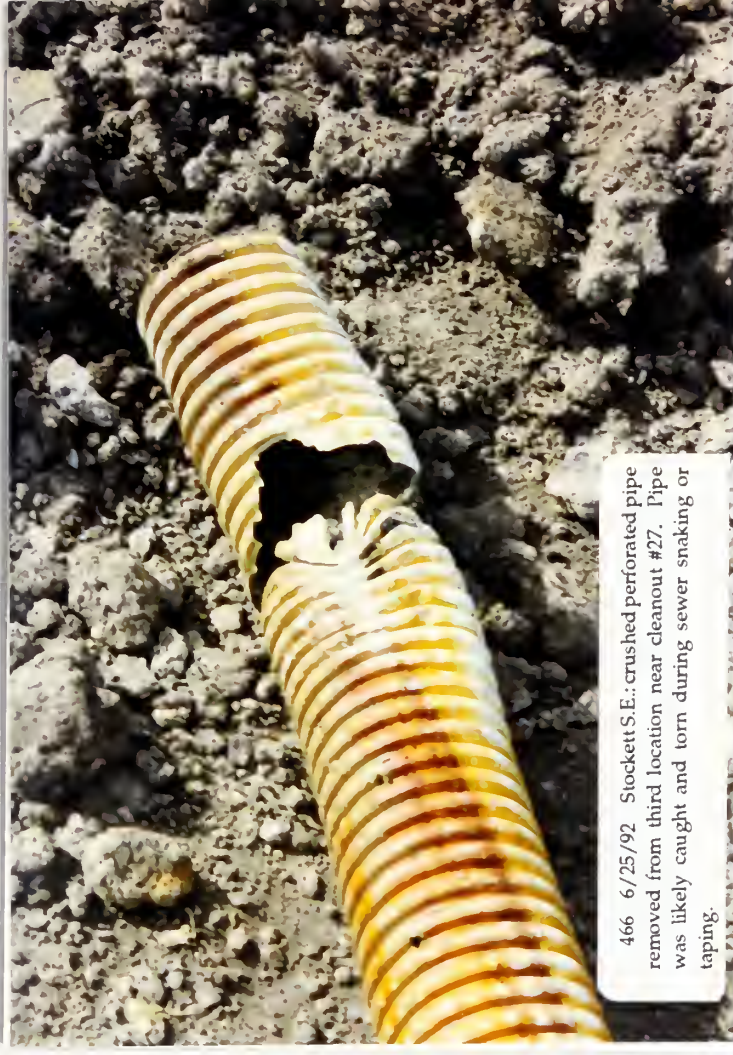
466 6/25/92 Stockett S.E.: crushed perforated pipe removed from third location near cleanout #27. Pipe was likely caught and torn during sewer snaking or tapping.

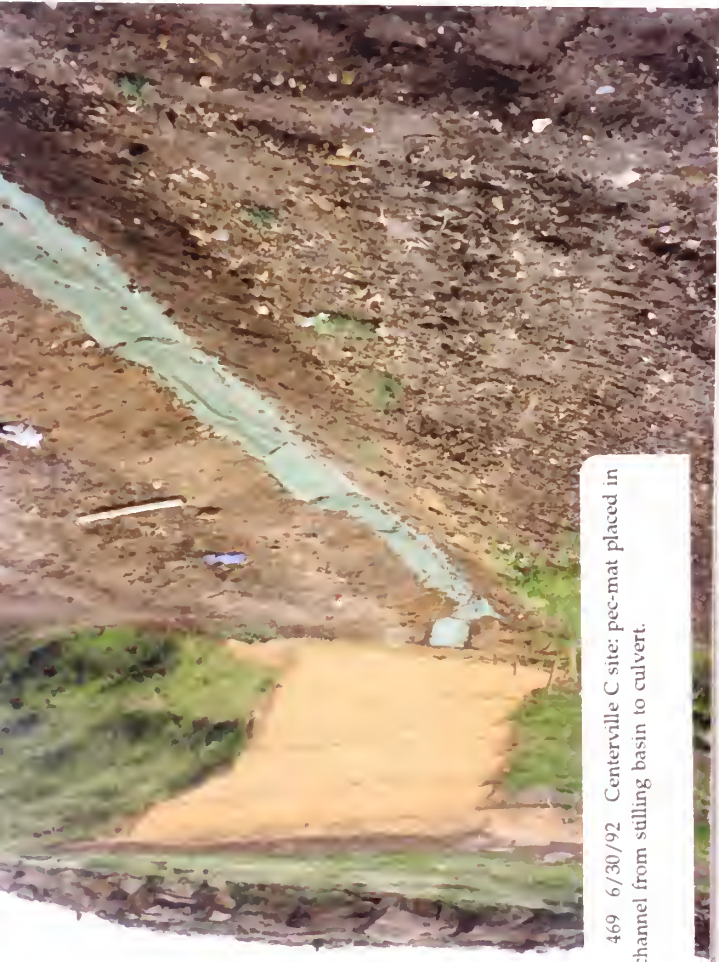
469 6/30/92 Centerville C site: pec-mat placed in channel from stilling basin to culvert.

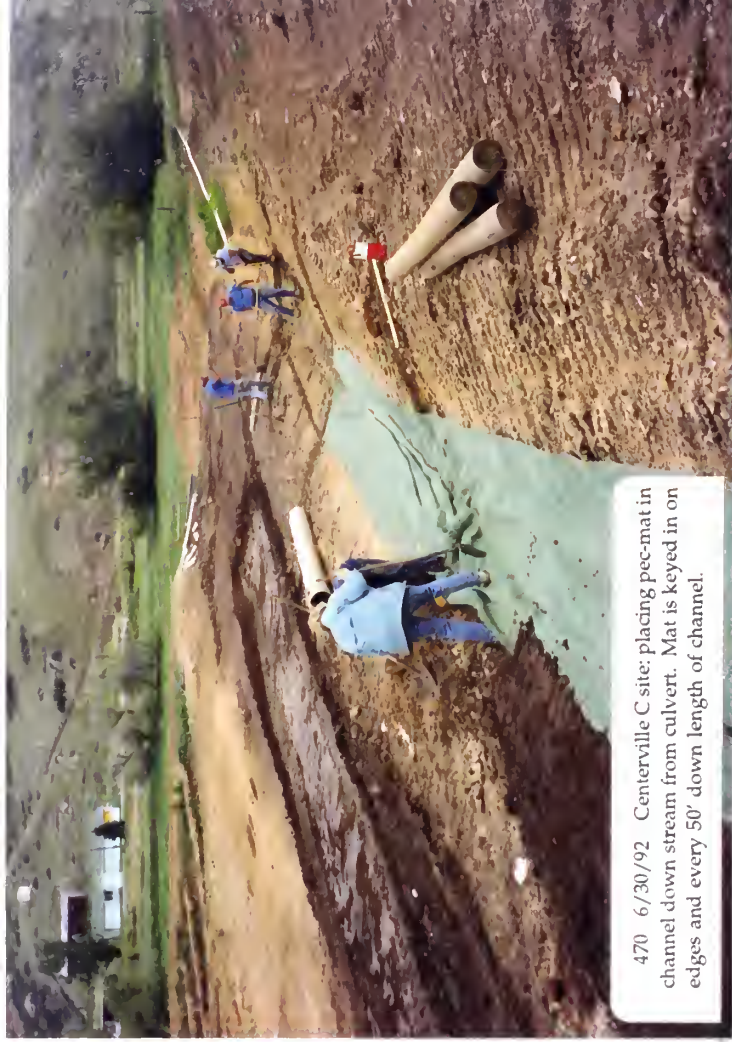
470 6/30/92 Centerville C site: placing pec-mat in channel down stream from culvert. Mat is keyed in on edges and every 50' down length of channel.

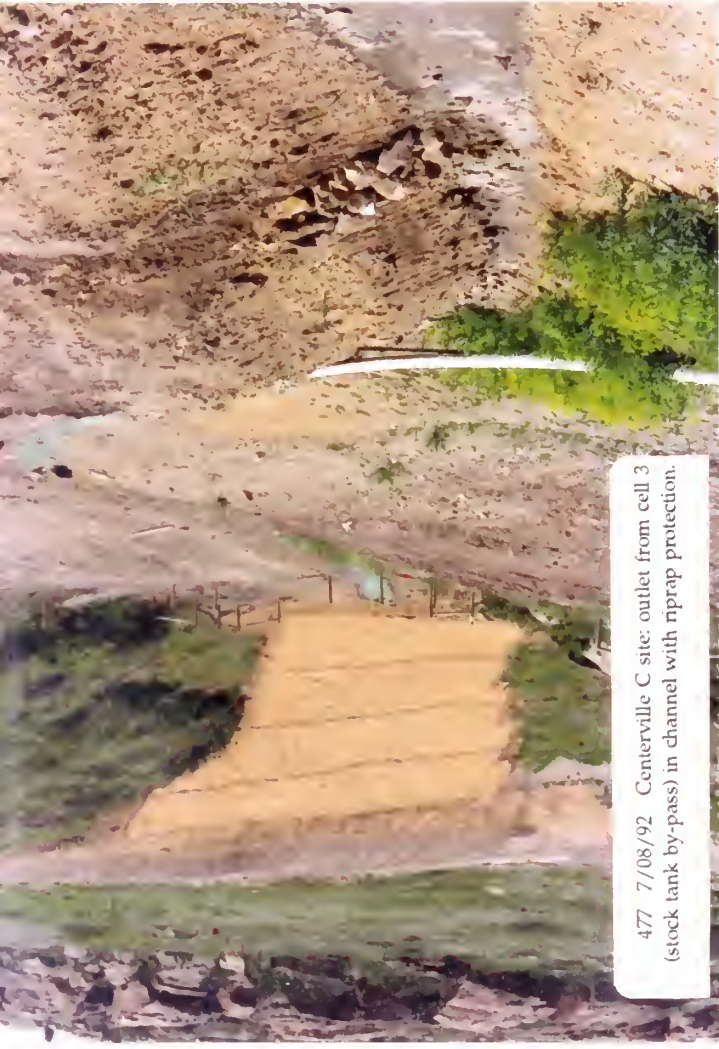
477 7/08/92 Centerville C site: outlet from cell 3 (stock tank by-pass) in channel with riprap protection.

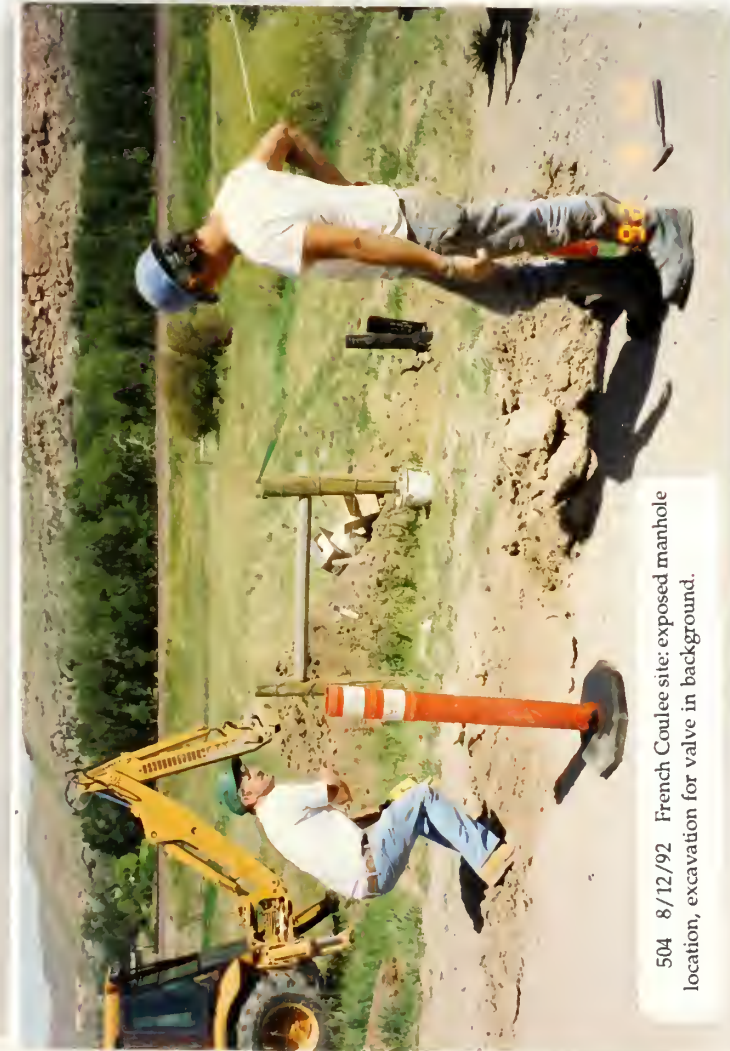
504 8/12/92 French Coulee site: exposed manhole location, excavation for valve in background.

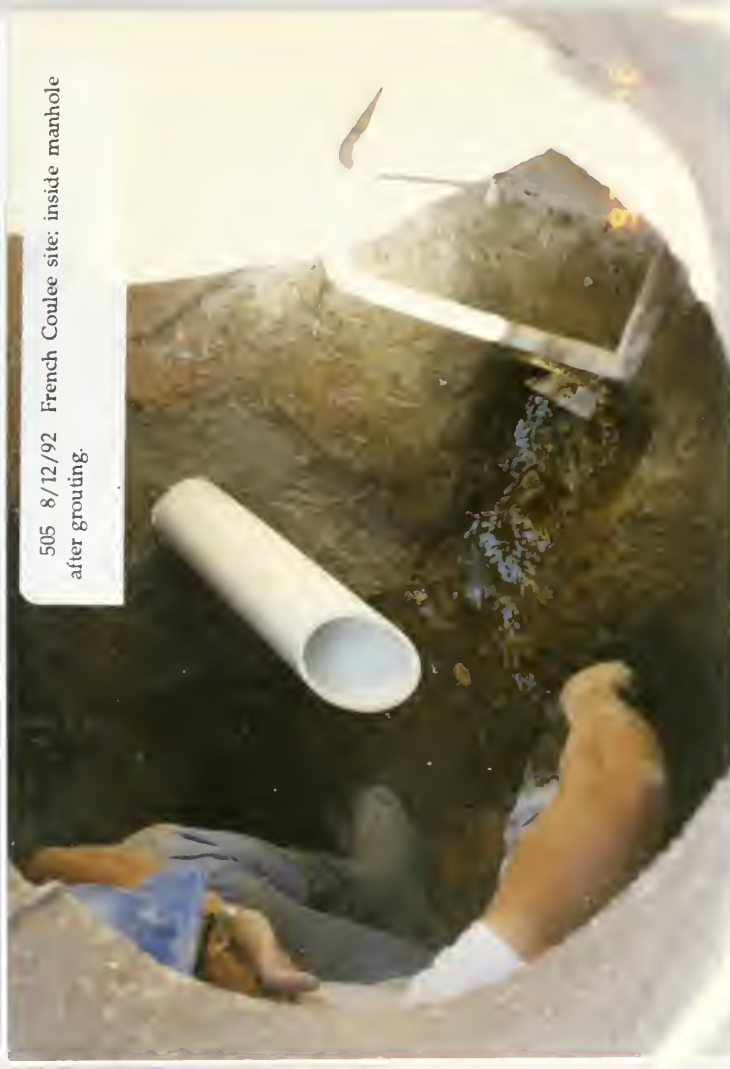
506 8/12/92 French Coulee site: inside manhole after grouting.

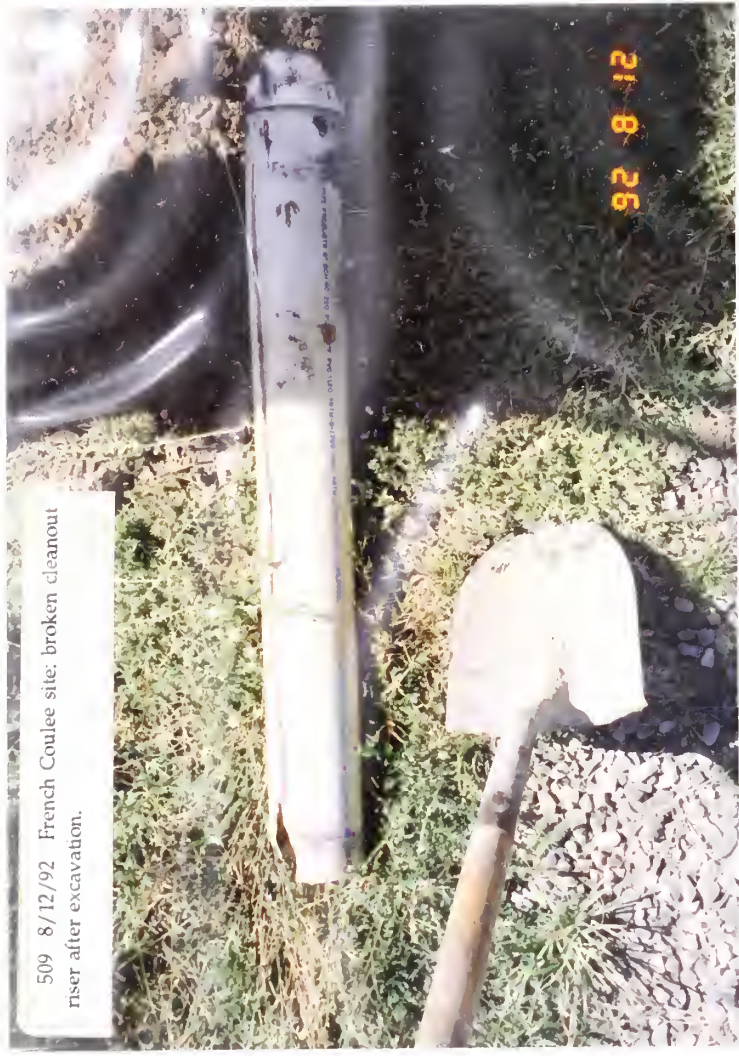
509 8/12/92 French Coulee site: broken cleanout riser after excavation.

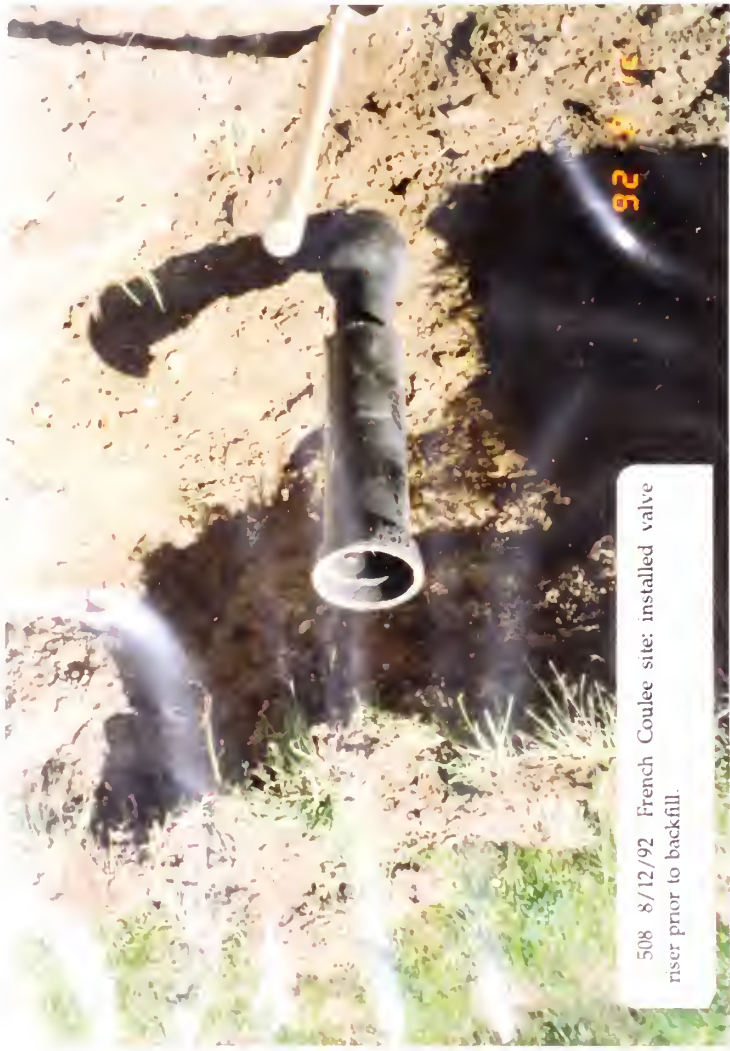
508 8/12/92 French Coulee site: installed valve riser prior to backfill.
